Recording, dismantling, cleaning and packing Cambridge University's 70ft-long Finback Whale skeleton

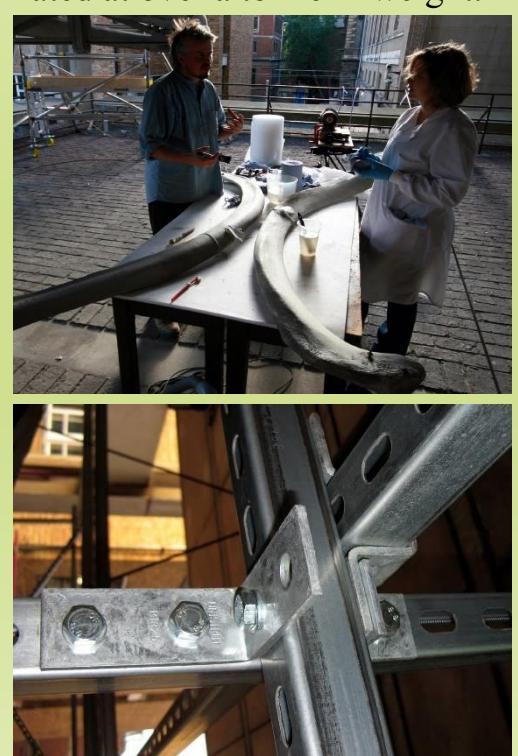
Despite the skeleton being cleaned about 10 years previously, the accumulated pigeon faeces were over an inch deep in places. Therefore before anything was dismantled the whole specimen was cleaned as thoroughly as possible with a stiff brush and a vacuum cleaner to get rid of the worst of the pigeon droppings and nesting material as well the general, dust, dirt and cobwebs etc. After being removed from the armature, each bone was thoroughly dry brushed again before being cleaned with the mild conservation detergent Synperonic A7 in water then the surface was cleaned of the detergent by further swabbing with water, whilst being patted dry frequently with paper towels so that the water did not soak in to the bone. The baleen was cleaned very gently with small soft brushes and a vacuum cleaner and was not 'wet cleaned'. All the rusty metalwork was cleaned with a spinning wire disk clamped to a bench, and then wiped clean with a damp rag, dried, painted and labelled. Where possible, the metal brackets were re-attached to specimens to keep them in context.

Left: cleaning ribs. Below left: galvanised steel Unistrut in use. Below: system of pulleys. moving the skull in its protective cage

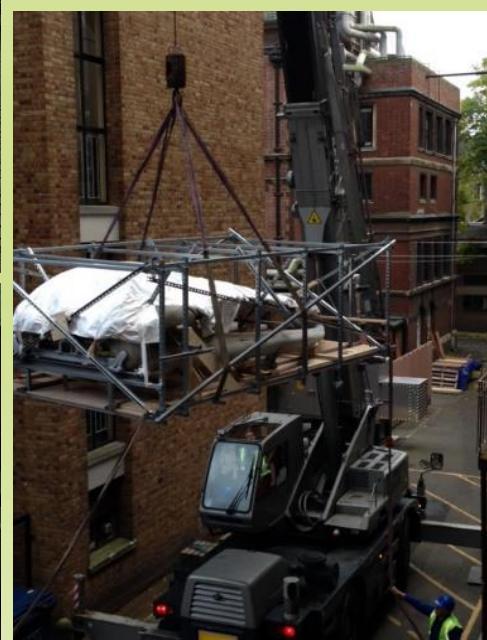
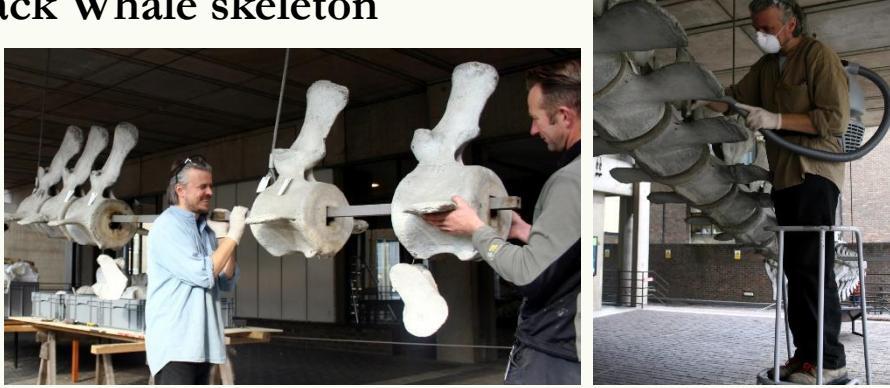
To move the skull into position in the 1990s it required 19 strong men, and injuries were sustained. Unfortunately the sutures of the skull are not fused and it had been sawn in half lengthways when initially prepared, so the whole structure was weaker than it might have been. Therefore, the skull itself could not support its own weight so a cage of galvanised steel Unistrut channel was built around it, bolted to a thick plywood base.

The protective cage was designed so that a crane would be able to lift it using straps placed underneath. Once the cage was built and Plastazote-lined wooden supports screwed securely underneath the bones, the weight had to be taken off the metal wires it was suspended from. Pneumatic 'Airjacks' were used (strong inflatable rubber 'pillows'). They were placed underneath the base of the cage to lift up the whole structure so that the wires could be undone and the weight transferred. Then a mobile crane moved the skull and mandible which together with the metalwork weighed 1.6 tons! A large shed was constructed especially to house the skull for the duration of the refurbishment project. Bespoke wooden crates were made for the baleen and forelimbs and Plastazote foam-lined wooden shelving made for the ribs (some of which were 2.85m long). The main supporting metal beam onto which the vertebrae were threaded was in two main sections, bolted together. The larger of these weighed in the region of 170Kg and was lowered with a
